ProxDot	
Rev A (Shipped)	
10/04/03	Monty Goodson

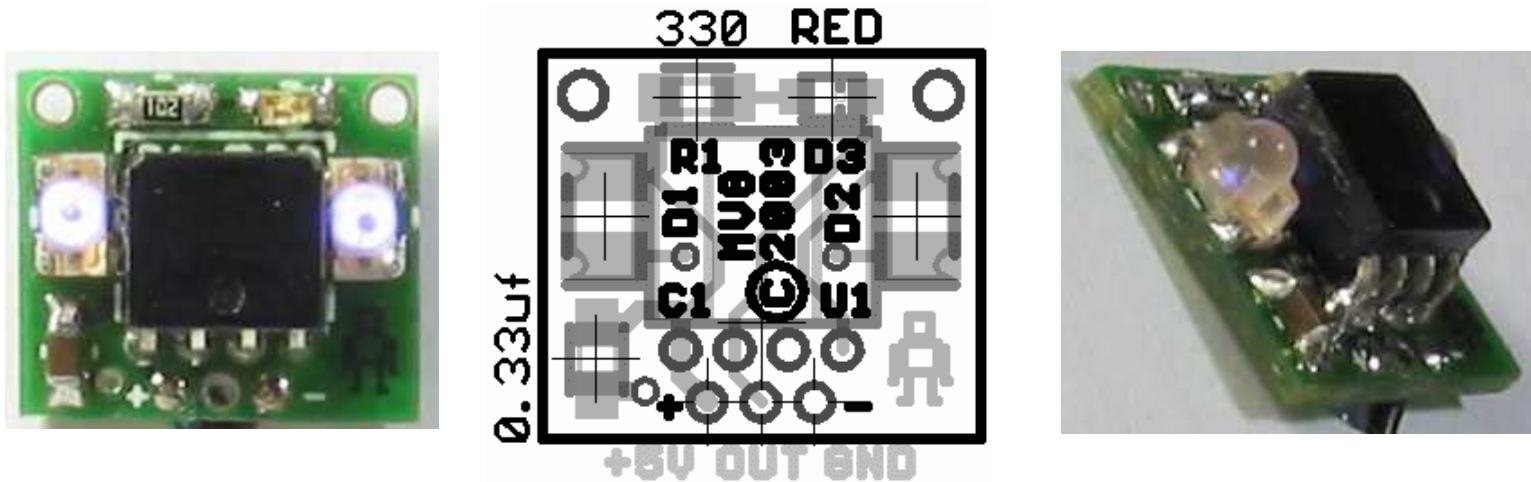
- 3.) Install the IR LED's
 - a. Note that gold pads on the IR LEDs wrap up one side of the part, where there are little bays cut into the sides (as shown in the above layout picture). These need to face outward. The IR LEDs should be centered in the pad, and should not be placed farther towards the center of the board than the white silkscreen line between the IR LED pads.

- 1.) Install all SMD components, except the IR LEDs (D1&D2.) Be sure to orient the indicator LED (D3) correctly. Look carefully at the top side (glass side) of the LED -- you should see the little square LED chip towards one end of the package. A magnifying glass helps here! The LED chip should line up with the short silkscreen lines between the pads for D3 on the board. In other words, the end of the LED with the chip goes towards the right.

- b. Test the IR LED's at this point, because once the heat-shrink is installed, you won't be able to easily replace them. The best way to test them is to use the diode-test function of a multi-meter: "+" to the left-most detector board pad (right below the "C1" silkscreen); "-" to the right-most detector board pad (right below the "U1" silkscreen.) There should be ~1.9-2.0V drop.
